Safety Edge in NC

Road Map

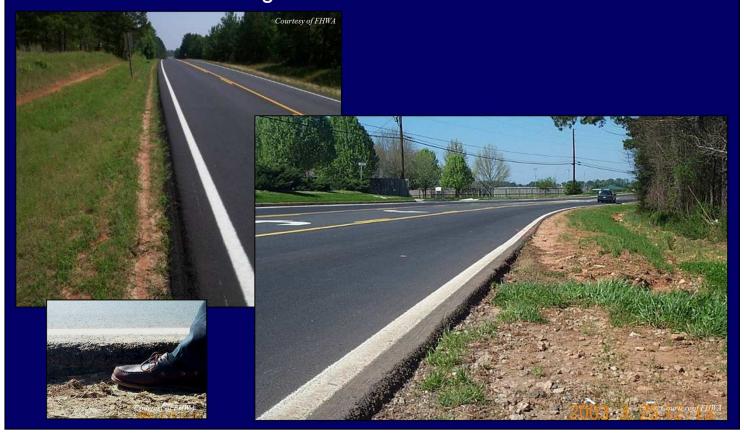
These photos are from sites in Georgia that DID NOT have Safety Edge. The photos demonstrate the edge drop offs that occur over time once vehicles have left the edge of pavement and rut out the dirt and grass shoulder material. The exposed pavement edge is nearly vertical, and in these photos is 2" to 6" in depth. The vertical edge, along with the depth of the drop off, causes increased tire friction on the side wall of a drivers tire when they run off the road and try to come back on. The driver tends to pull the wheel hard in a steering maneuver to get back on the road. Once the tire releases from the vertical edge from increased side wall tire friction, the vehicles tends to shoot back up onto the pavement causing the driver to lose control of his vehicle.

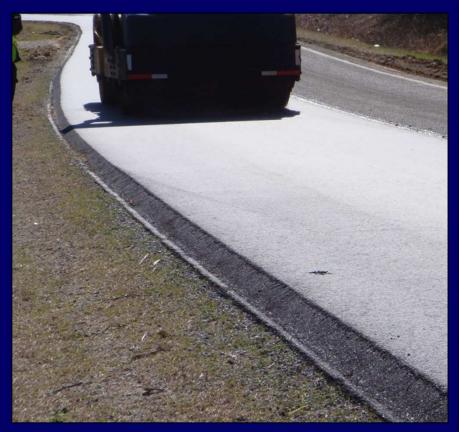
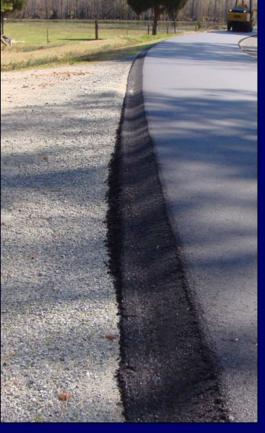
Hot Mix Installation – SR 1355

These photos are from the first ½ mile of implementation. Notice in the picture on the right how the safety edge shape is in play for most of the slope, however with the depth of the edge drop-off, it causes the asphalt to fall off when it exceeds the safety edge shape.

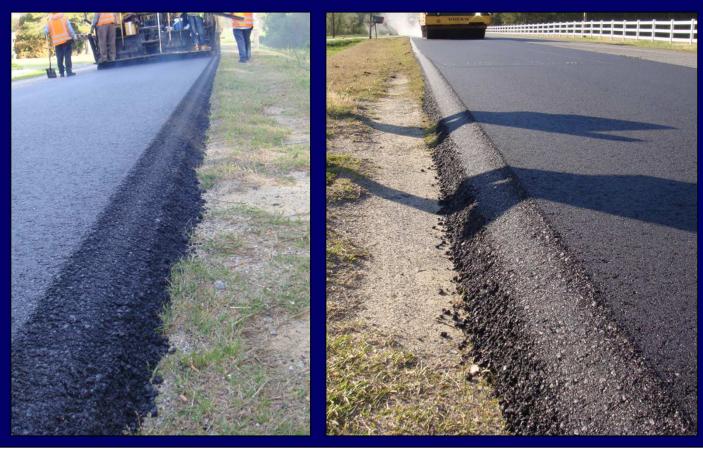
Hot Mix Installation – SR 1938

Notice in the pictures above how the safety edge shape is in play for most of the slope, however with the depth of the edge drop-off, it causes the asphalt to fall off when it exceeds the safety edge shape.

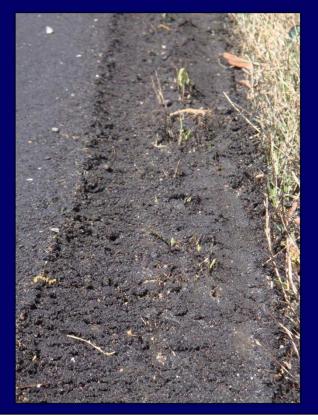
The photos above demonstrate when clipping of the shoulders IS NOT completed prior to resurfacing and the asphalt breakpoint is placed far right of the existing edge of pavement. The asphalt breakpoint in this photo was approximately 12" to 16" to the right of the existing edge of pavement. The approximate location of the existing edge of pavement is highlighted in the photo on the right with a red arrow.

This occurred on approximately 200' of approximately 10 miles observed.

Shoulders Should Be Clipped Before

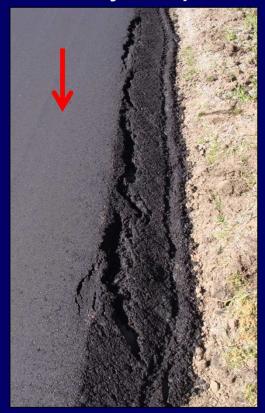
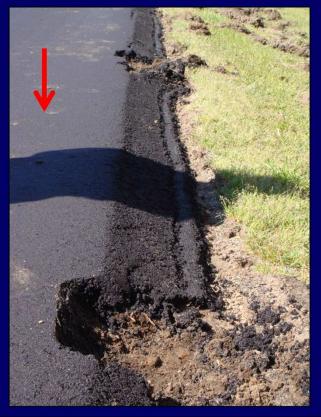
The photos above demonstrate when clipping of the shoulders IS NOT completed prior to resurfacing and the asphalt breakpoint is placed far right of the existing edge of pavement. The asphalt breakpoint in this photo was approximately 12" to 16" to the right of the existing edge of pavement. When this section was rolled, the extension of the new asphalt beyond the existing edge of pavement as well as the new pavement being laid over existing grass, caused the pavement to crack at this location. The approximate location of the existing edge of pavement is highlighted in both photos above with a red arrow.

This occurred on approximately 500' of approximately 10 miles observed.

Shoulders Should Be Clipped Before

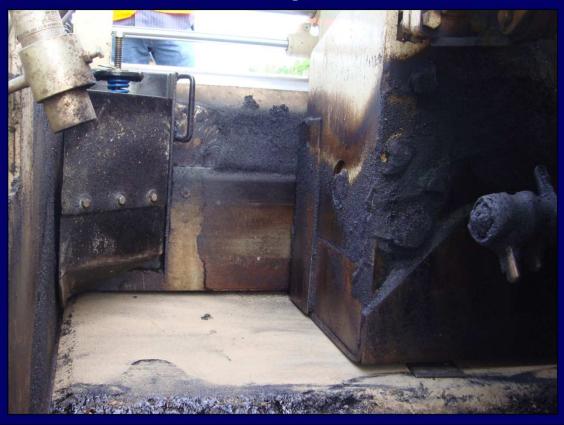
• Internal Device – Worked Marginal on this Screed

This slide demonstrates the safety edge placed on a 10' paver on a section that was being resurfaced with 12' lanes. If the paver had to go to 11' lanes somewhere on this cross-section of road, the safety edge would have to come off of the machine.

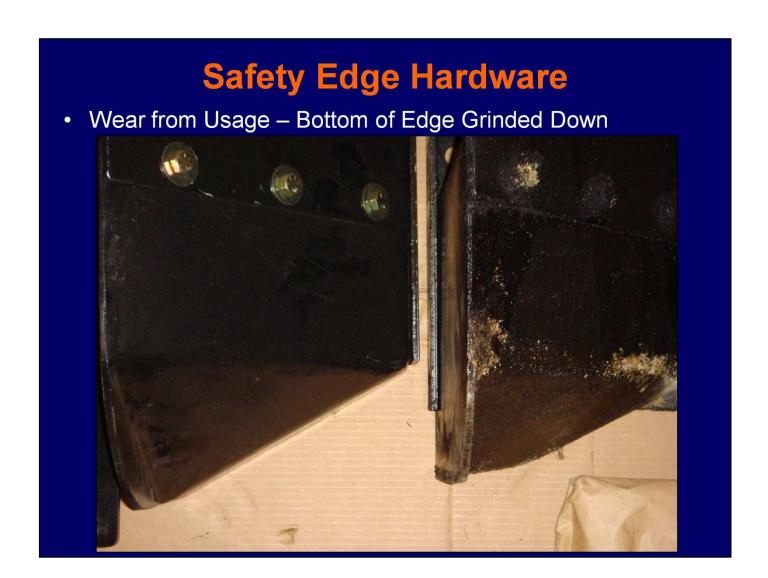
This slide demonstrates the wear on the device after paving 10 miles of road in Robeson County.

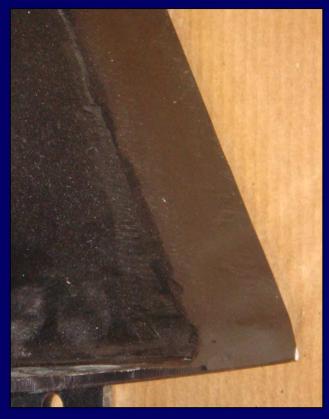
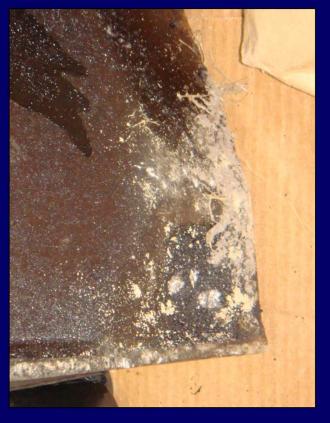
• Wear from Usage – Bottom of Edge Grinded Down

This slide demonstrates the wear on the device after paving 10 miles of road in Robeson County.

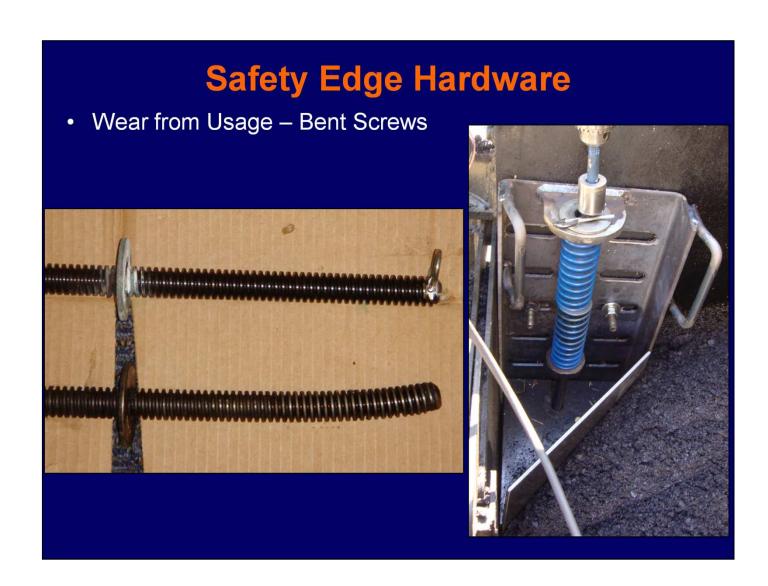
This slide demonstrates the damage to the screw device if the shoe is not raised and lowered properly and the device happens to snag objects along the roadside (such as concrete driveways).

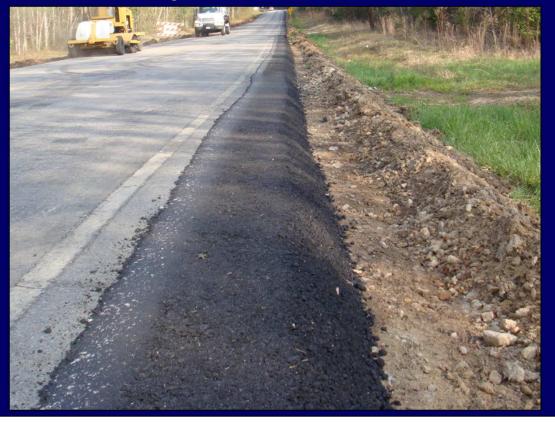
Notice the 45 degree edge of pavement left from the 1 foot shoulder extension.

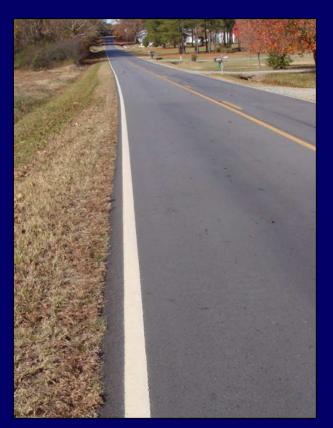
Hot Mix Installation – SR 1355 (6 months)

These photos are the 6 month after observation. Notice the pen in the photo on the right, the safety edge shape is fully exposed.

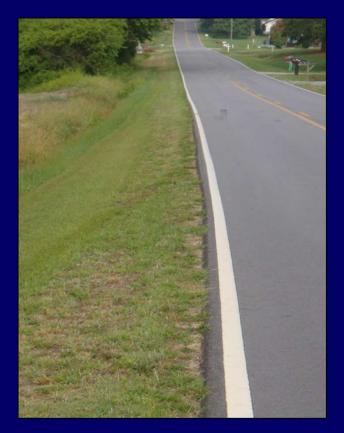
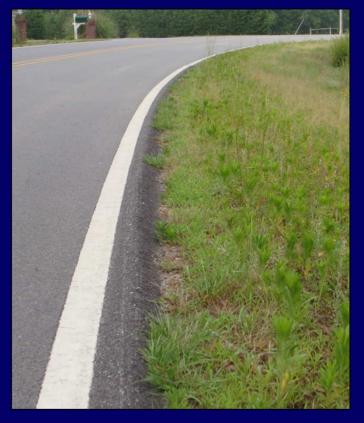
Hot Mix Installation – SR 1355 (1 year)

These photos are the 1 year after observation. Notice the pen in the photo on the right, the safety edge shape is fully exposed.

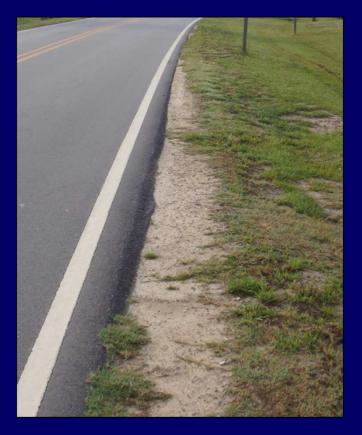
• Warm Mix Installation – SR 1547 (1 year)

These photos are the 1 year after observation. Notice the pen in the photo on the right, the safety edge shape is fully exposed.

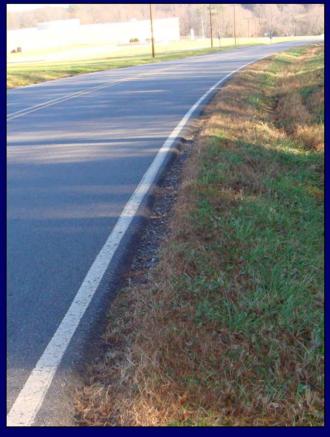
• Observation Site C (3.0 years)

This site DID NOT re-rut in the first after 1 period but DID rut over the next 1.5 years in the after 2 period.

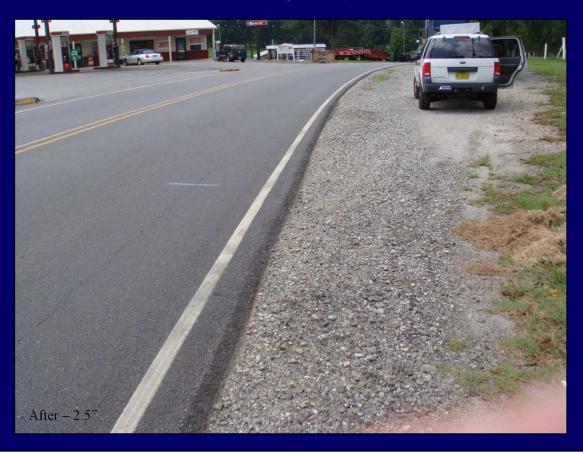
Observation New Site A (1.5 years)

This is a site where a rut did not exist in the before period, but a rut occurred in the after 1 period (2.5 inch drop-off). Notice that edge is exposed in the after period and appears to be holding up to traffic. Notice the tractor-trailer parked in front of the state vehicle. This site is parking for tractor-trailers who eat at the dinner across the street. This edge is getting heavy traffic.

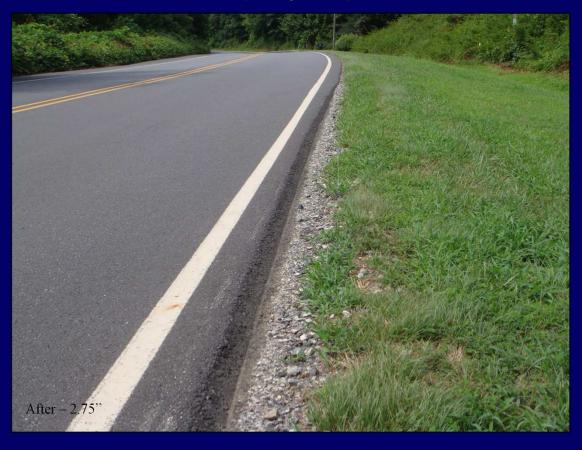
Observation New Site B (1.5 years)

This is a site where a rut did not exist in the before period, but a rut occurred in the after 1 period (2.75 inch drop-off). Notice that edge is exposed in the after 1 period and appears to be holding up to traffic.
